Manhole Inspection Summary

Manhole # S15C1_005MH

Location Address: **2930 james st**

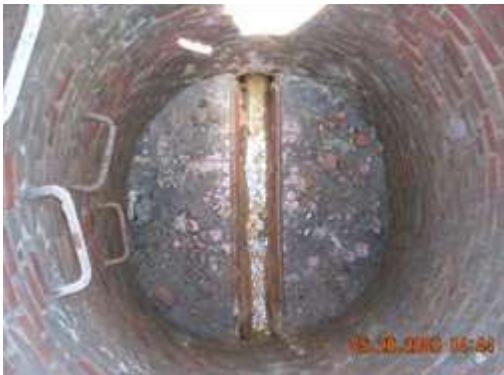
Defect 3

Condition: ☐ Sound ☐ Cracked ☐ Root Intrusion ☐ Deteriorated ☐ Leaks ☒ **Debris**

bench cond debris

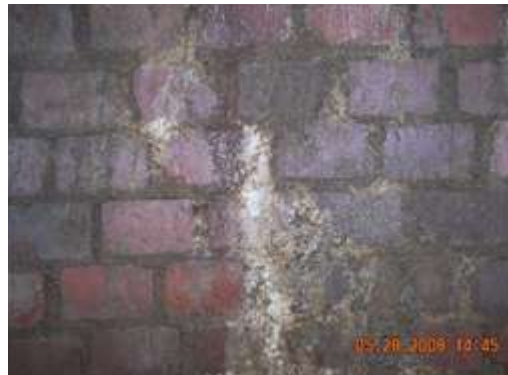
Defect 2

Infiltration: ☐ None ☐ Joint ☐ Cracks ☐ Mortar ☐ Roots ☒ **Wall**

infiltration @ corbel wall

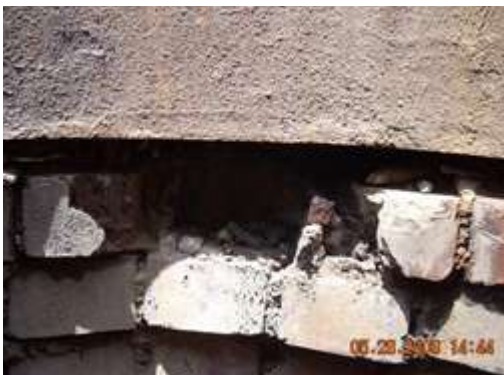
Defect 1

Condition: ☐ Sound ☐ Cracked ☐ Root Intrusion ☐ Loose Brick ☒ **Deteriorated**

deteriorated chimney bricks

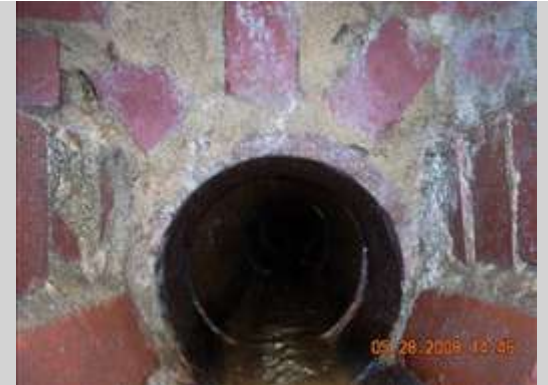
12 O'Clock Outflow

Pipe Height: **8.4** (in.) Rod and Bar (Angled)
Pipe Material: **Clay** ☐ Pipe Lined
Invert Depth: **10.55** (ft.) Flow Characteristics: **Slow**
Deposits: ☒ None ☐ Mud ☐ Sludge ☐ Debris ☐ Grease
Silt Depth: **0** (in.) Deposits Extent:
Infiltration: **None** Pipe Seal Cond: **Sound**

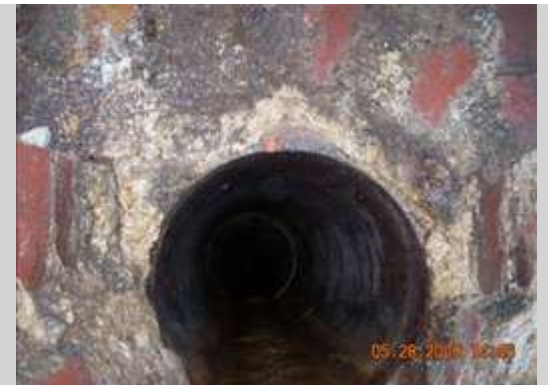
6 O'Clock Inflow

Pipe Height: **8.4** (in.) Rod and Bar (Angled)
Pipe Material: **Clay** ☐ Pipe Lined
Invert Depth: **10.43** (ft.) Flow Characteristics: **Slow**
Deposits: ☒ None ☐ Mud ☐ Sludge ☐ Debris ☐ Grease
Silt Depth: **0** (in.) Deposits Extent:
Infiltration: **None** Pipe Seal Cond: **Sound**
